Technical and ethical issues in the Bhopal gas disaster

Abstract

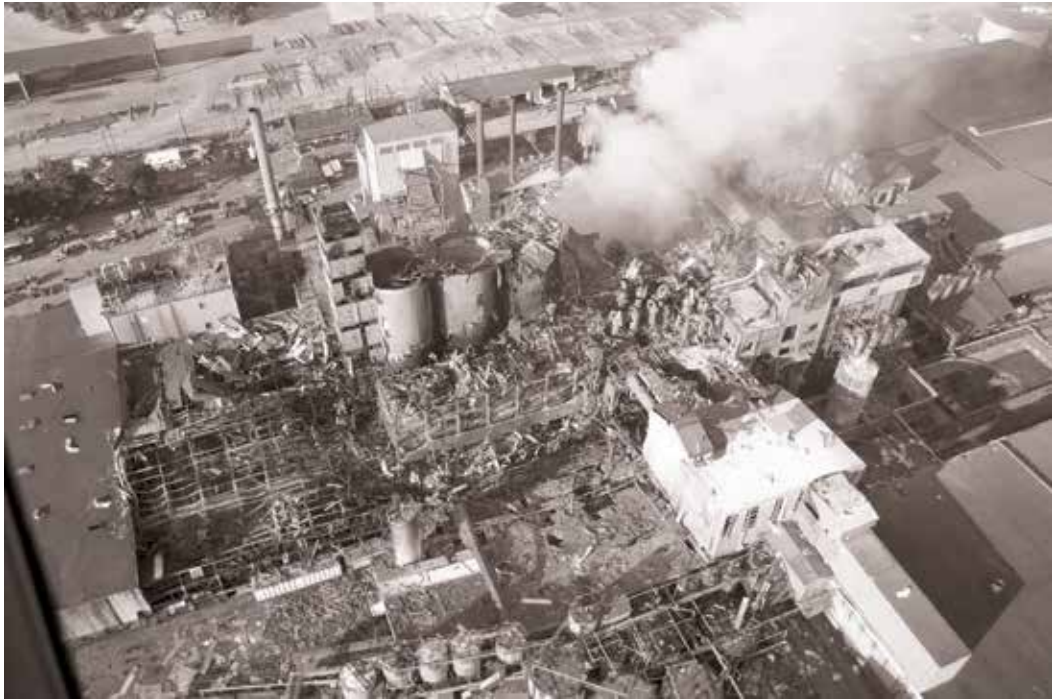
Fig. 1: The Bhopal plant during the accident

It is estimated that a total of 30 metric tons of MIC gas was emitted over a period of 45 - 60 minutes before the process could be shut down (see Figure 1). Because the gas cloud was composed of materials denser than the air, it stayed close to the ground and spread into the neighbouring Bhopal community (Eckerman, 2005). It is reported that people of smaller stature – especially children – were the worst affected by the disaster. The main cause of death was choking, with the death toll estimated at 2000 by some (Rice, 2006), and as high as 8,000 by others (Eckerman 2006). The affected area, spanning a radius of 15 kilometres, is shown in Figure 2.

The technical causes of the disaster were analysed in detail in a report that was commissioned by the relevant state government (Madya Pradesh Government 1987). In this report, the main technical cause was identified as the emission of the toxic chemical, methyl isocyanate (MIC), caused by a leakage of water into a tank holding the chemical. According to the report, the leakage was caused by the malfunctioning of a lip-blind plate leading to the tank. The water entering the tank sparked a runaway chemical reaction, accelerated by contaminants in the tank, high temperatures and also by the presence of iron from corroding non-stainless steel pipes. The reaction increased the temperature in the holding tank to over 200 degrees Celsius, which in turn forced a large quantity of MIC gas out of the tank and into the surrounding air (Eckerman, 2005).
